Ford Site, Cork City, Co. Cork

Stage 1 Road Safety Audit

240002-X-00-X-XXX-RP-DBFL-CE-0004

November 2024

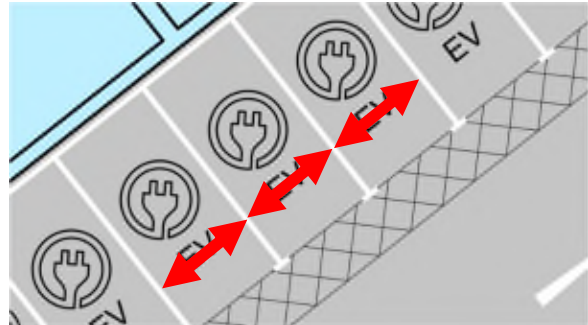
Location (G1) – EV Car Parking Spaces

The width of the EV car parking spaces appear to be a similar width to the standard bays. It is unclear if any widening of spaces is proposed to accommodate pedestrian manoeuvrability within the space to connect EV chargers. Failure to provide a sufficient buffer zone between these spaces could result in the electric cables presenting trip hazards to vehicle occupants as they travel between their vehicle and the charge point.

A sufficient buffer zone should be provided between EV charger bays. EV charger units should be positioned so that vehicles are able to be parked within the bay.

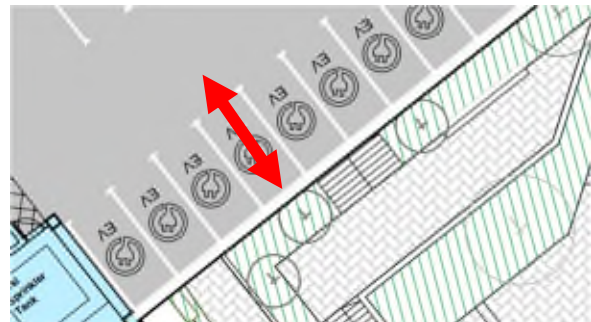
In addition, at EV charger spaces where no buffer to the aisle is provided, it is unclear if the positioning of an EV charging unit will result in parked vehicles protruding into the aisle. Should vehicles protrude into the aisle, this could result in material damage to vehicles should a collision occur between vehicles exiting the spaces on the opposite side of the aisle or with vehicles travelling past.

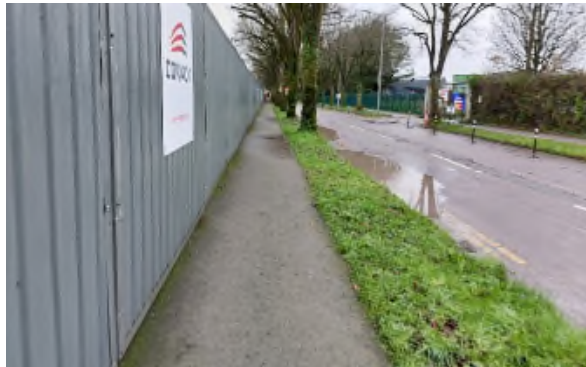
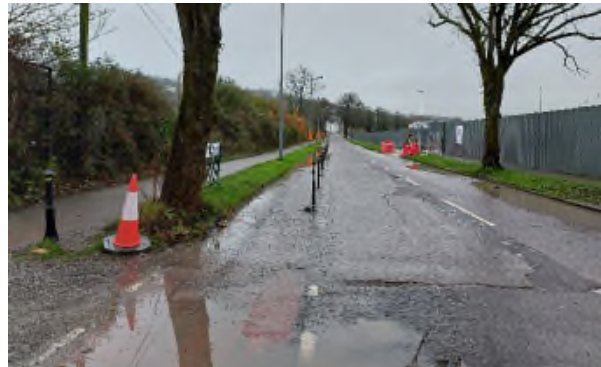
Location (G2) – Existing Ponding

At the time of the site visit, which took place after a consistent period of rainfall, there was evidence of ponding to the west of the proposed site access location. The auditors are concerned that further development in this vicinity could exacerbate this existing problem. Excessive ponding

could cause aquaplaning as cars travel through affected areas or slippery conditions during freezing temperatures which could result in vehicle loss of control type incidents.

It is recommended that the design team take cognisance of the existing drainage issues in their design.

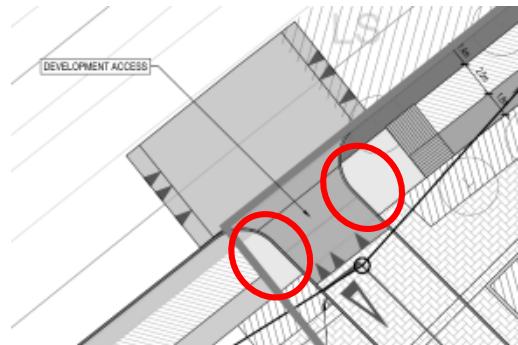
Location (S1) –Pedestrian & cycle crossing across site access

Cyclists and pedestrians are proposed to enter a shared space on approach to the site access junction. Whilst appropriate tactile paving is proposed to be provided at the transition between the segregated facilities and the shared facility, no tactile paving has been proposed at the crossing point. Accordingly, visually impaired pedestrians could misread this layout and continue across the junction in the path of vehicular traffic potentially resulting in vehicle / pedestrian conflicts.

At detailed design stage, the appropriate tactile paving should be incorporated at the crossing point.

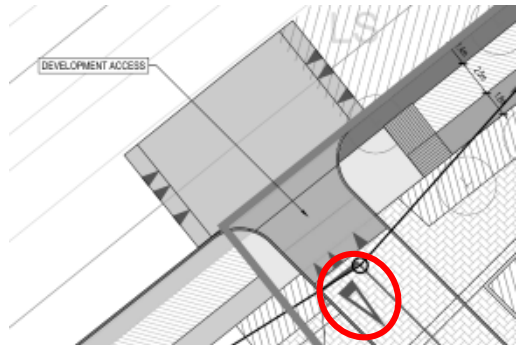
Location (S2) –Site access junction control

A Yield arrangement is proposed at the site access junction. This junction control coupled with the slightly skewed approach to the junction could result in drivers failing to stop before entering the main road potentially leading to vehicle / vehicle collisions should a visibility splay not be achievable for a Yield arrangement.

It is recommended that the more onerous visibility splay required for a Yield arrangement are achievable. If this is not achievable, a STOP control arrangement should be provided.

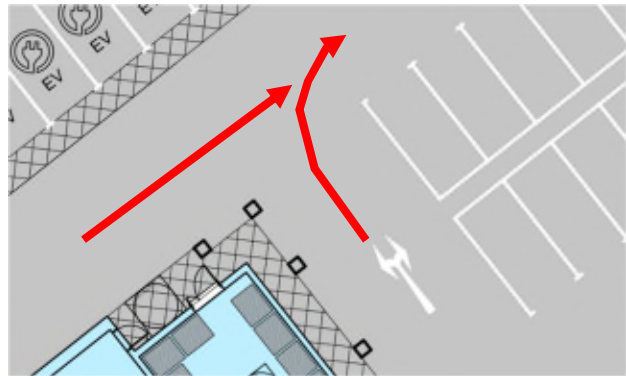
Location (S3) – Car Park Arrangement

A one-way arrangement is proposed within the undercroft car park. At the location where the southern car park section joins the northern section, no junction control is proposed. This could result in confusion as to who has priority potentially leading to vehicle collisions.

At detailed design stage, the priority arrangement within the car park should be made obvious.

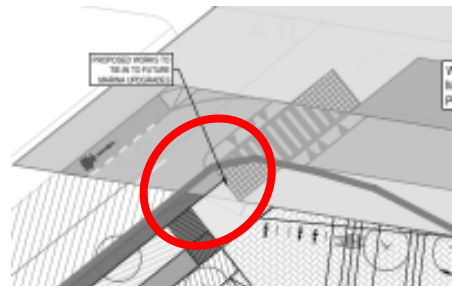
Comment C2 – Tie-in to Marina Promenade Scheme

There appears to be a drafting error at the tie-in between the proposed scheme and the Marina Promenade Scheme. It is assumed that this will be tied in correctly prior to planning submission.
