Ford Site, Cork City, Co. Cork

Stage 1 Road Safety Audit

240002-X-00-X-XXX-RP-DBFL-CE-0004

November 2024

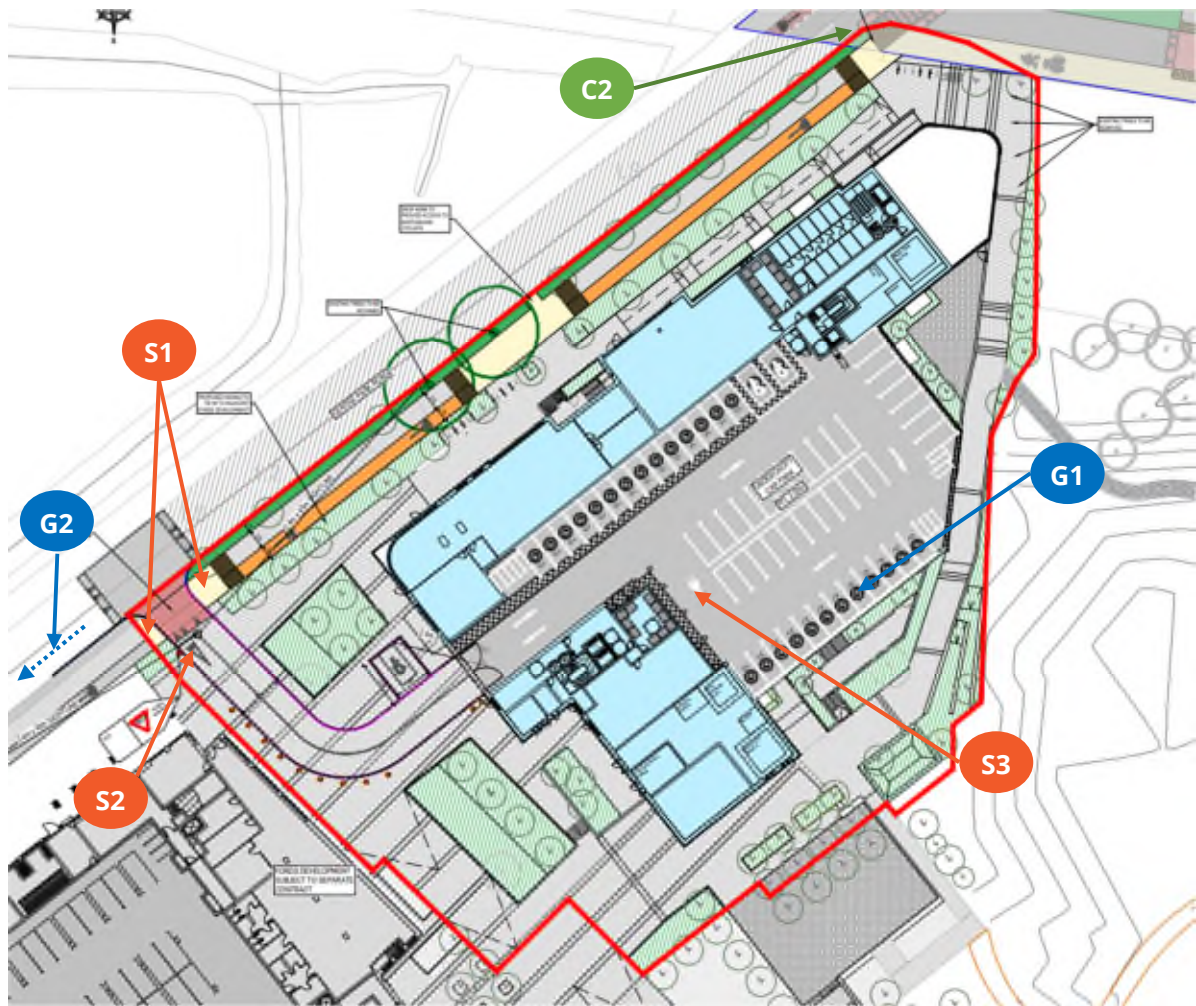
Appendix A : Problem Location Figure

The width of the EV car parking spaces appear to be a similar width to the standard bays. It is unclear if any widening of spaces is proposed to accommodate pedestrian manoeuvrability within the space to connect EV chargers. Failure to provide a sufficient buffer zone between these spaces could result in the electric cables presenting trip hazards to vehicle occupants as they travel between their vehicle and the charge point.

In addition, at EV charger spaces where no buffer to the aisle is provided, it is unclear if the positioning of an EV charging unit will result in parked vehicles protruding into the aisle. Should vehicles protrude into the aisle, this could result in material damage to vehicles should a collision occur between vehicles exiting the spaces on the opposite side of the aisle or with vehicles travelling past.

could cause aquaplaning as cars travel through affected areas or slippery conditions during freezing temperatures which could result in vehicle loss of control type incidents.

A Yield arrangement is proposed at the site access junction. This junction control coupled with the slightly skewed approach to the junction could result in drivers failing to stop before entering the main road potentially leading to vehicle / vehicle collisions should a visibility splay not be achievable for a Yield arrangement.

It is recommended that the design team take cognisance of the existing drainage issues in their design.

It is recommended that the more onerous visibility splay required for a Yield arrangement are achievable. If this is not achievable, a STOP control arrangement should be provided.
